# A Nondestructive Inspection System for the Inspection of Wear Surfaces in Tank Track Shoes

Valery F. Godínez-Azcuaga, Richard D. Finlayson  
Physical Acoustics Corporation

Basavaraju B. Raju  
U.S. Army Tank and Armaments Command

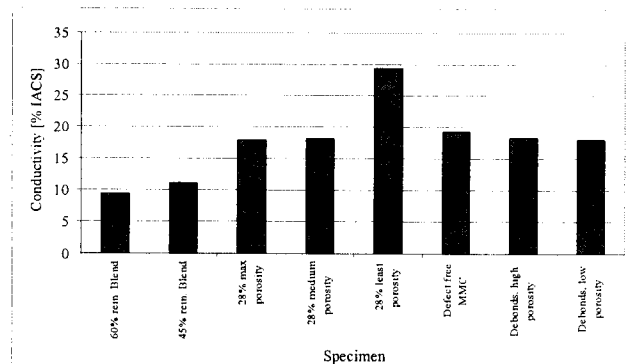
Figure 1. Conductivity measurements (point by point) on control defect specimens.

Point measurements were performed of the eight controlled-defect MMC specimens, and the results indicate the EC sensitivity to property variations as reinforcement and porosity content. Figure 1 shows the average conductivity of the specimens taken over 9 measurements on each specimen. Table 2 summarizes the results of the point EC measurements, and shows average conductivity and standard deviation, both in % IACS.

The results shown in Figure 1 and Table 2 indicate that increasing the porosity decreases the average conductivity. The porosity changes from 29.45% IACS for the specimen with lowest porosity (specimen 5) to 17.92% IACS for the specimen with highest porosity (specimen 3). The medium porosity specimen (number 4) has a conductivity of 18.3% IACS.

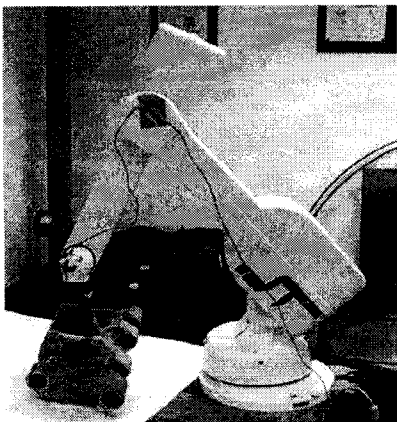
Figure 8. Robotic arm undergoing test at PAC.

An inspection system based on a robotic arm will offer great flexibility in terms of application of the UT/EC inspection technique to pieces of different geometries, therefore it would have great potential for its application in the automotive industry. Currently, a series of tests are being performed at PAC using the robotic arm shown in Figure 8.
